M.O. FIGUEIREDO^{1,2,✉}
T.P. SILVA^{1,2}
J.P. VEIGA²

Analysis of degradation phenomena in ancient, traditional and improved building materials of historical monuments

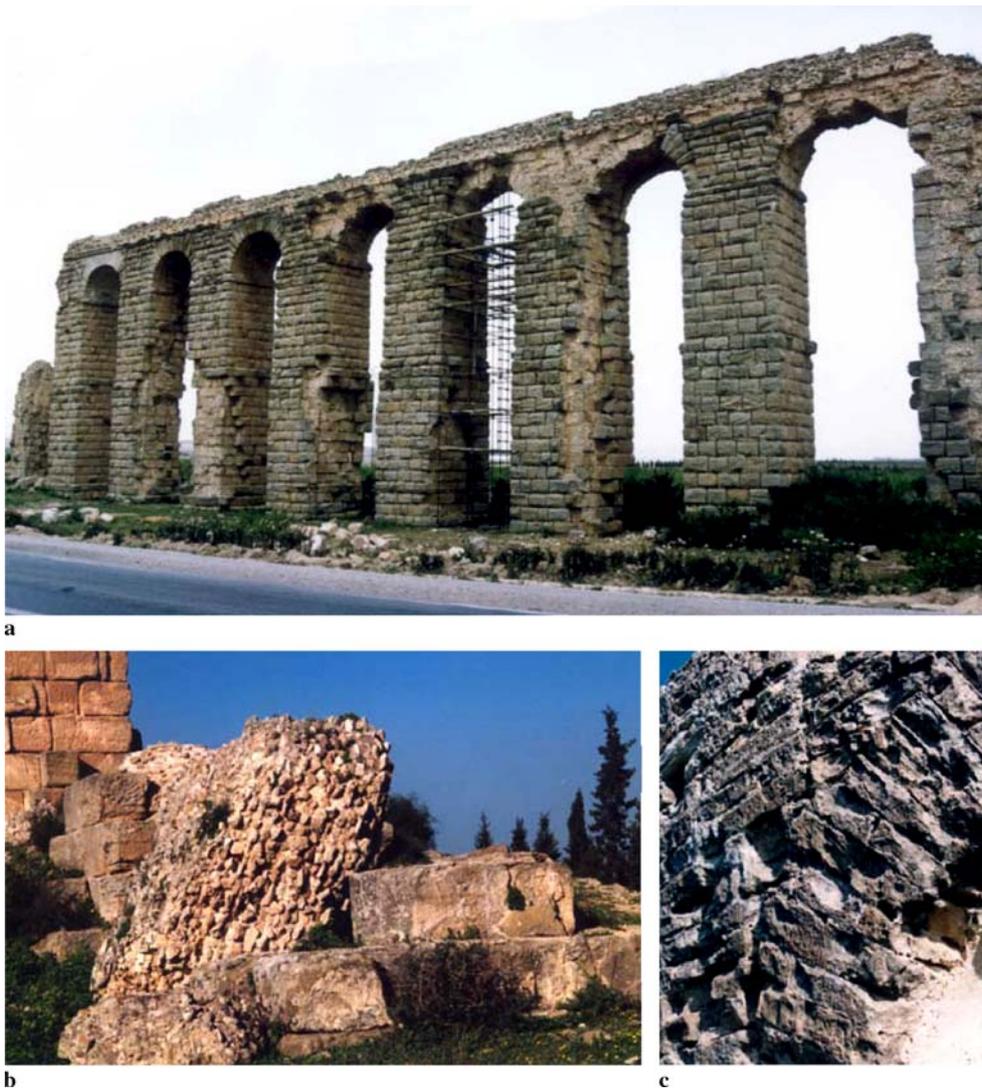
FIGURE 3 Aqueduct of Carthage: (a) Roman arches in risk of dismantling being subjected to consolidation works; (b) fallen-down blocks of opus caementitium and original sandstone ashlars (c) detail of ashlar blocks displaying stone alteration by alveolization

Integrating the common cultural patrimony of Mediterranean basin countries, this monument has been the object of detailed international studies focused on the description of Roman ashlar (Fig. 3) – blocks of sandstone, occasionally limestone – plus masonries (opus caementicium, op. signinum, op. incertum), on the characterization of medieval re-

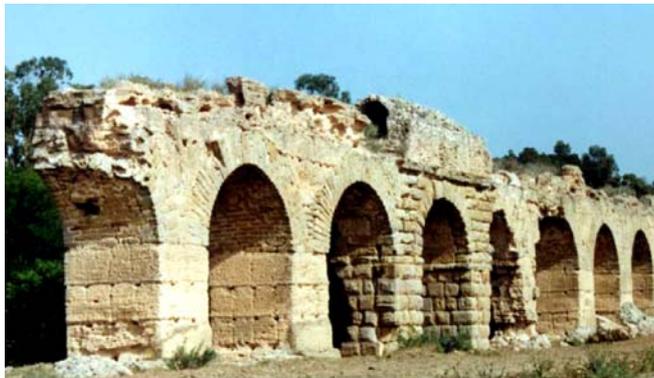
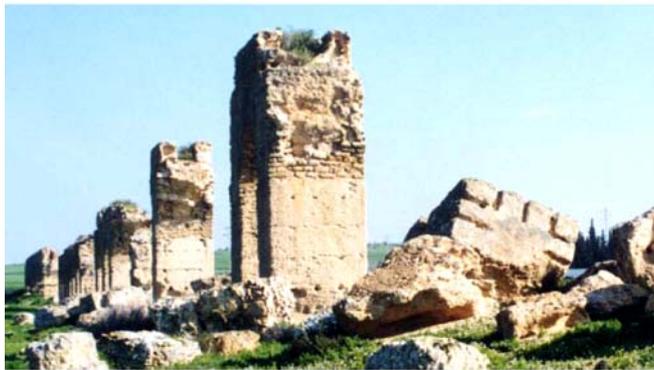
FIGURE 4 Hafsid reconstruction of the Aqueduct: (a) sector enclosing a Roman arch and original water conduit; (b) dismantled blocks of Hafsid pillars

The building material used in medieval (Hafsid) reconstructions (Fig. 4a) was a mixture of lime and reddish argillaceous earth with hydraulic properties (still used nowadays under the name of torba). The adopted constructive technique is clearly expressed in fallen blocks manufactured in that period (Fig. 4b): Pillars were built using wood moulds progressively displaced from bottom to top; after a section had dried a thin layer of chalk or lime was spread over the surface before starting the new section.
